03.07.13

# A Renovation to 480 Grand

## Phase 1

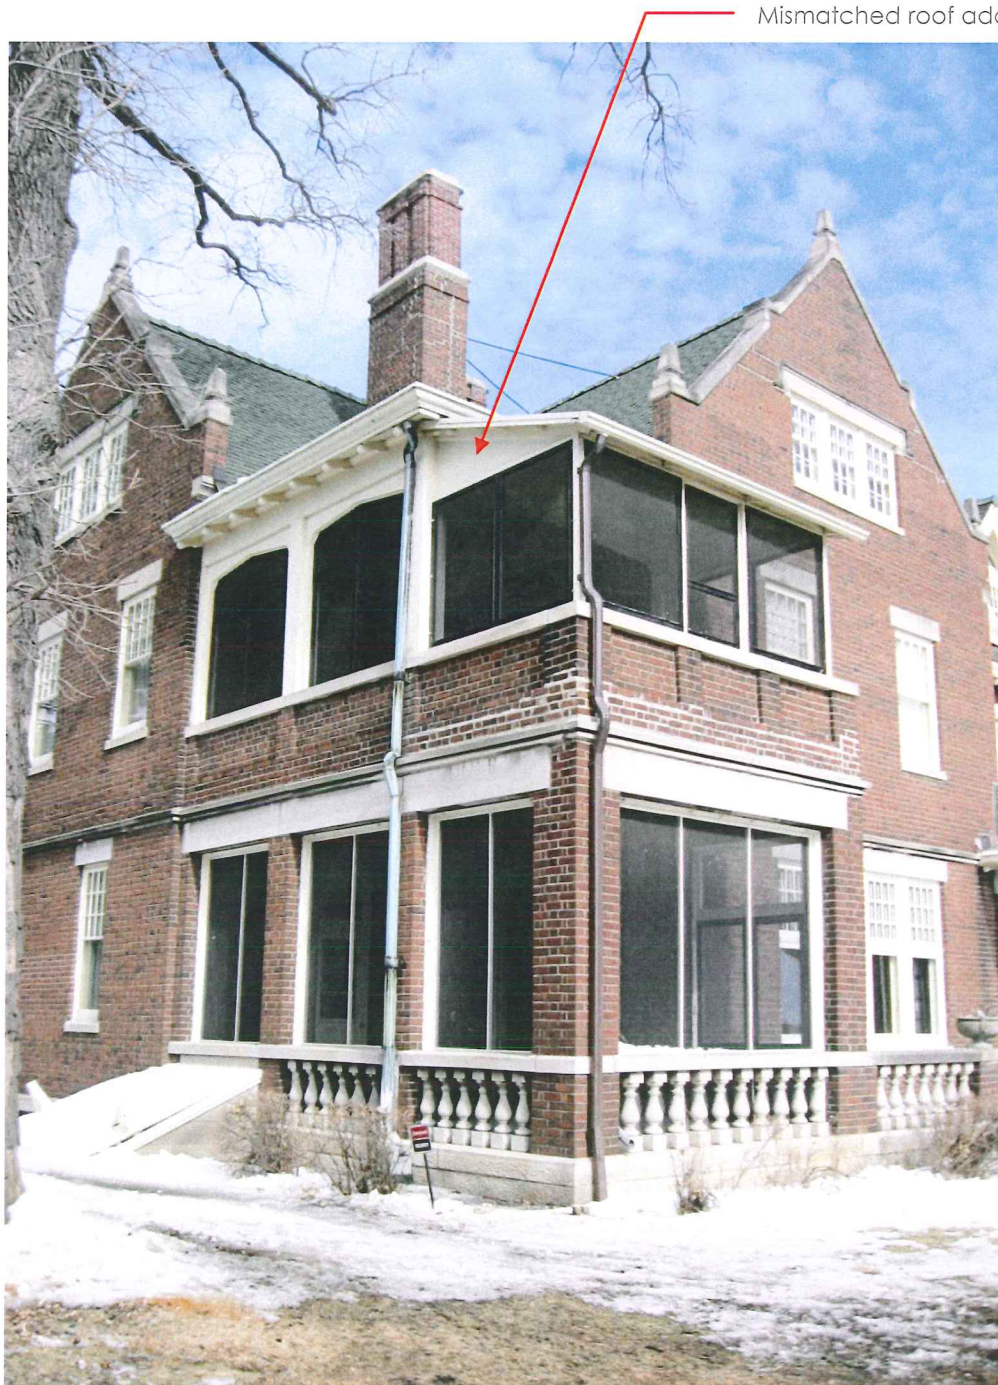
Porch Elevation

Mismatched roof addition & modification

- Removing and replacing the dilapidated screens and adding storm windows.
- Re-tuck point previous brick repair.
- Removing the two roof structure and replacing it with a new flat roof that matches the existing flat portion. All materials, detailing, brackets, etc. will match the existing features on the home.
- Adding Bluestone pavers on a pedestal system over the existing floor.
- Removing the downspout in the South-East interior corner. This was part of modifying the exterior balcony some time ago.
- Adding a door in the current location of a window in the Guest Bedroom. This will give access and egress to that bedroom.

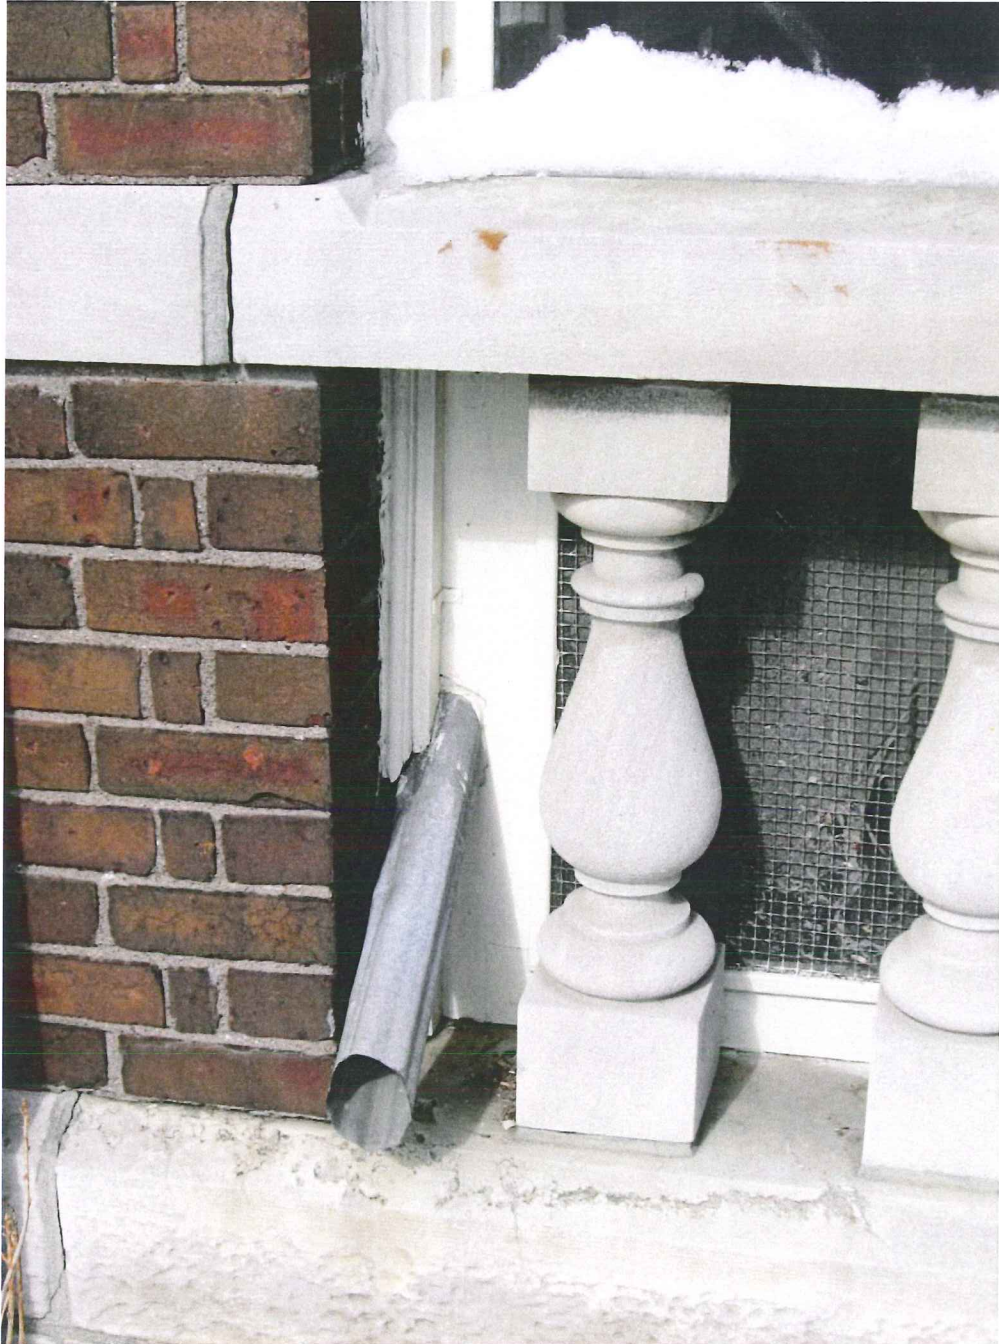
Screen Porch Interior Downspout

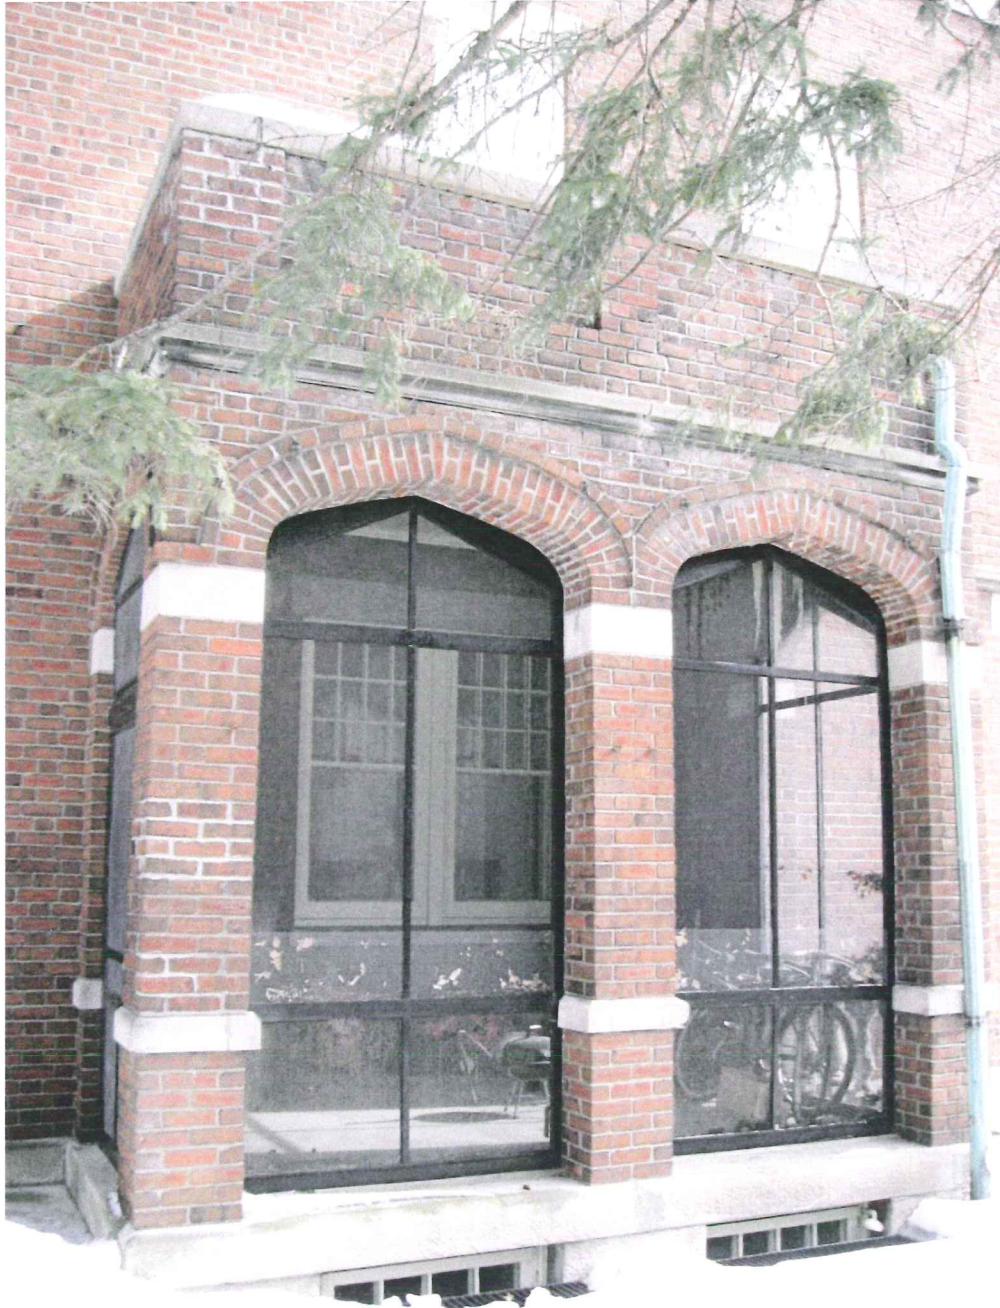
Kitchen Screen Porch

- Removing and replacing the dilapidated screens.
- Adding Bluestone pavers on the existing concrete slab.
- Repairing the dilapidated balusters on the South face of the Porch.

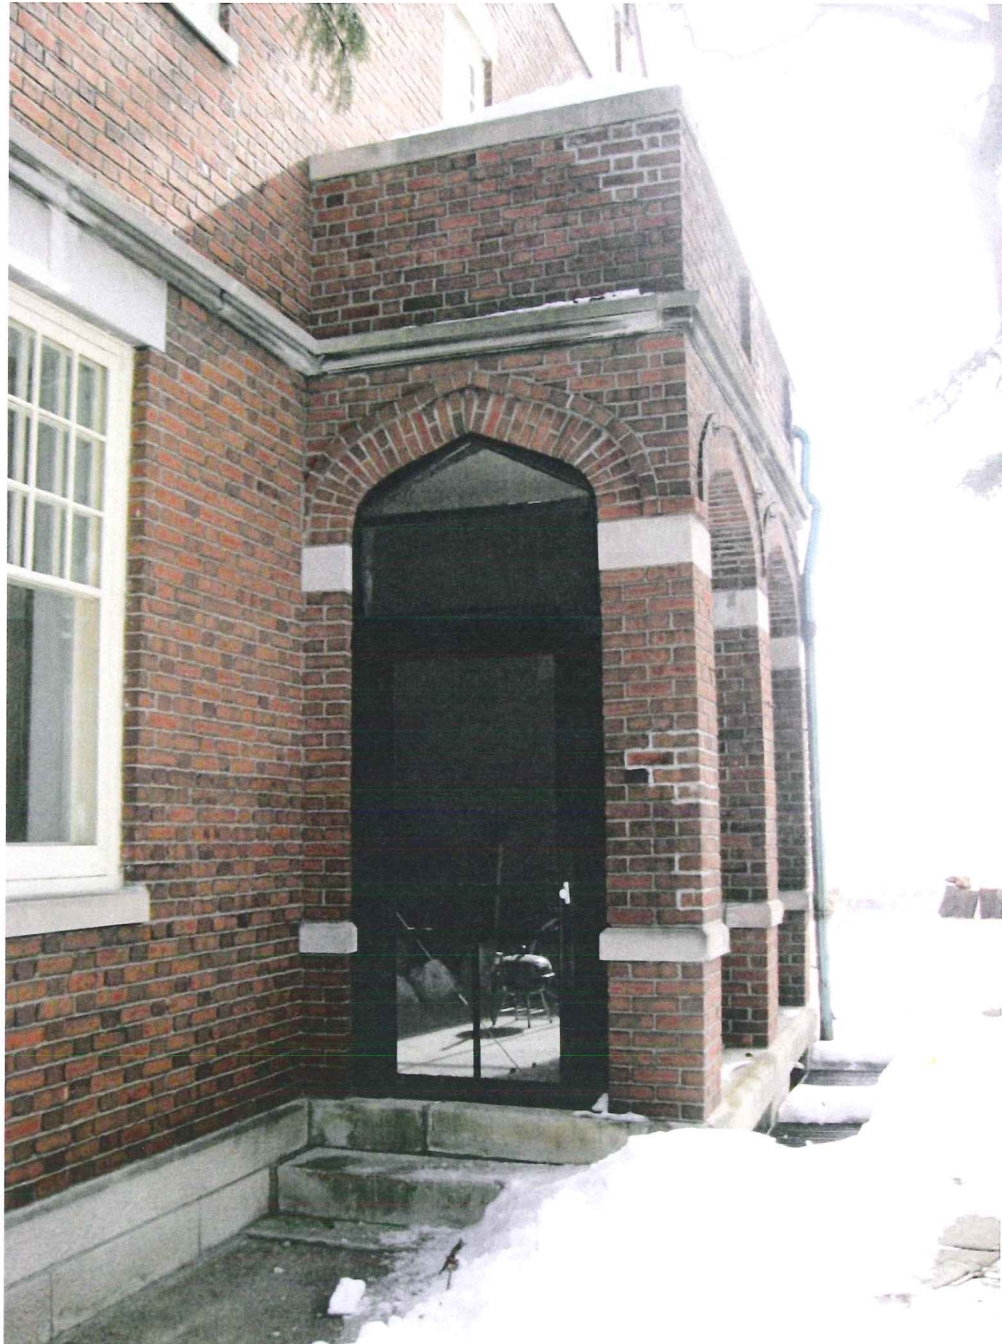
Kitchen Screen Porch

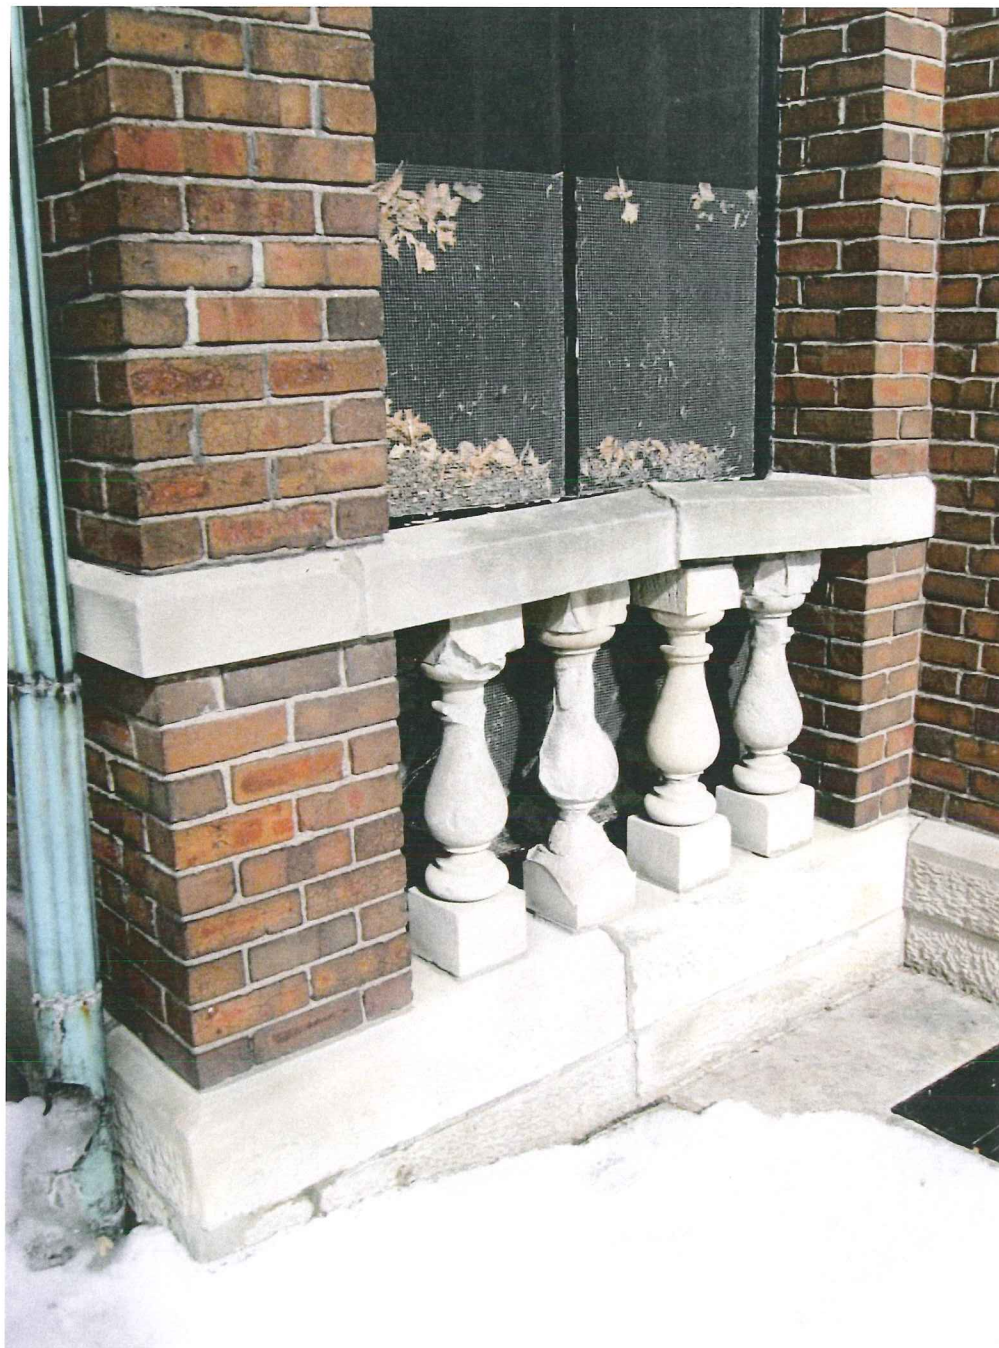
Kitchen Screen Porch Balusters

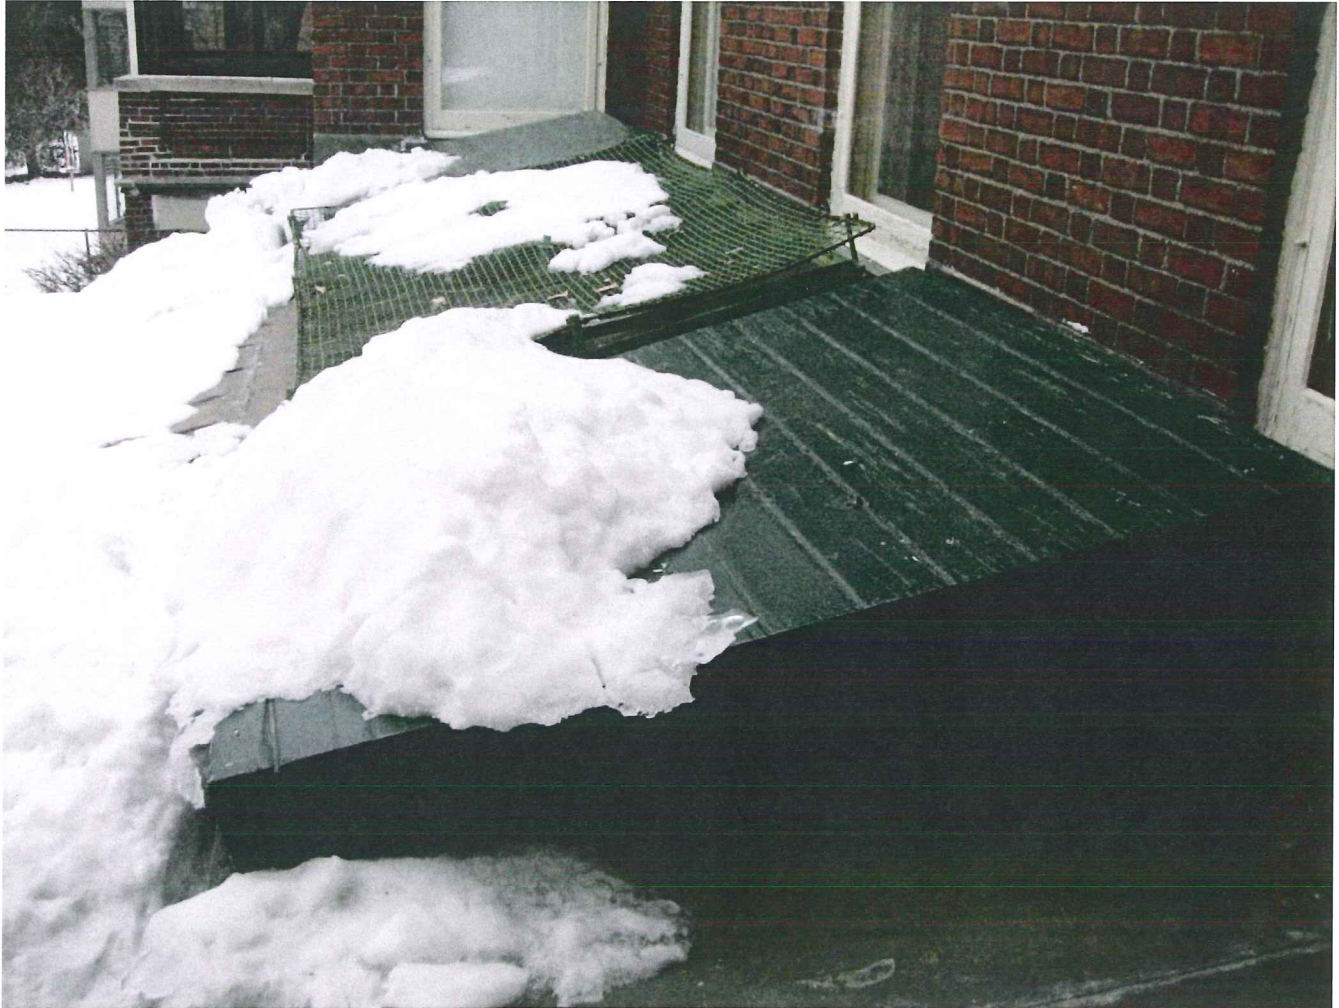
Solarium Skylight Covers

- Removal of the existing green metal cage and plywood covers over the Solarium skylights. We will replace them with new safety glass skylights from

Velux. New curbs will be created, as required, and copper flashing will be installed to match the existing roofing material. No changes will occur to the interior stained glass decorative panels.

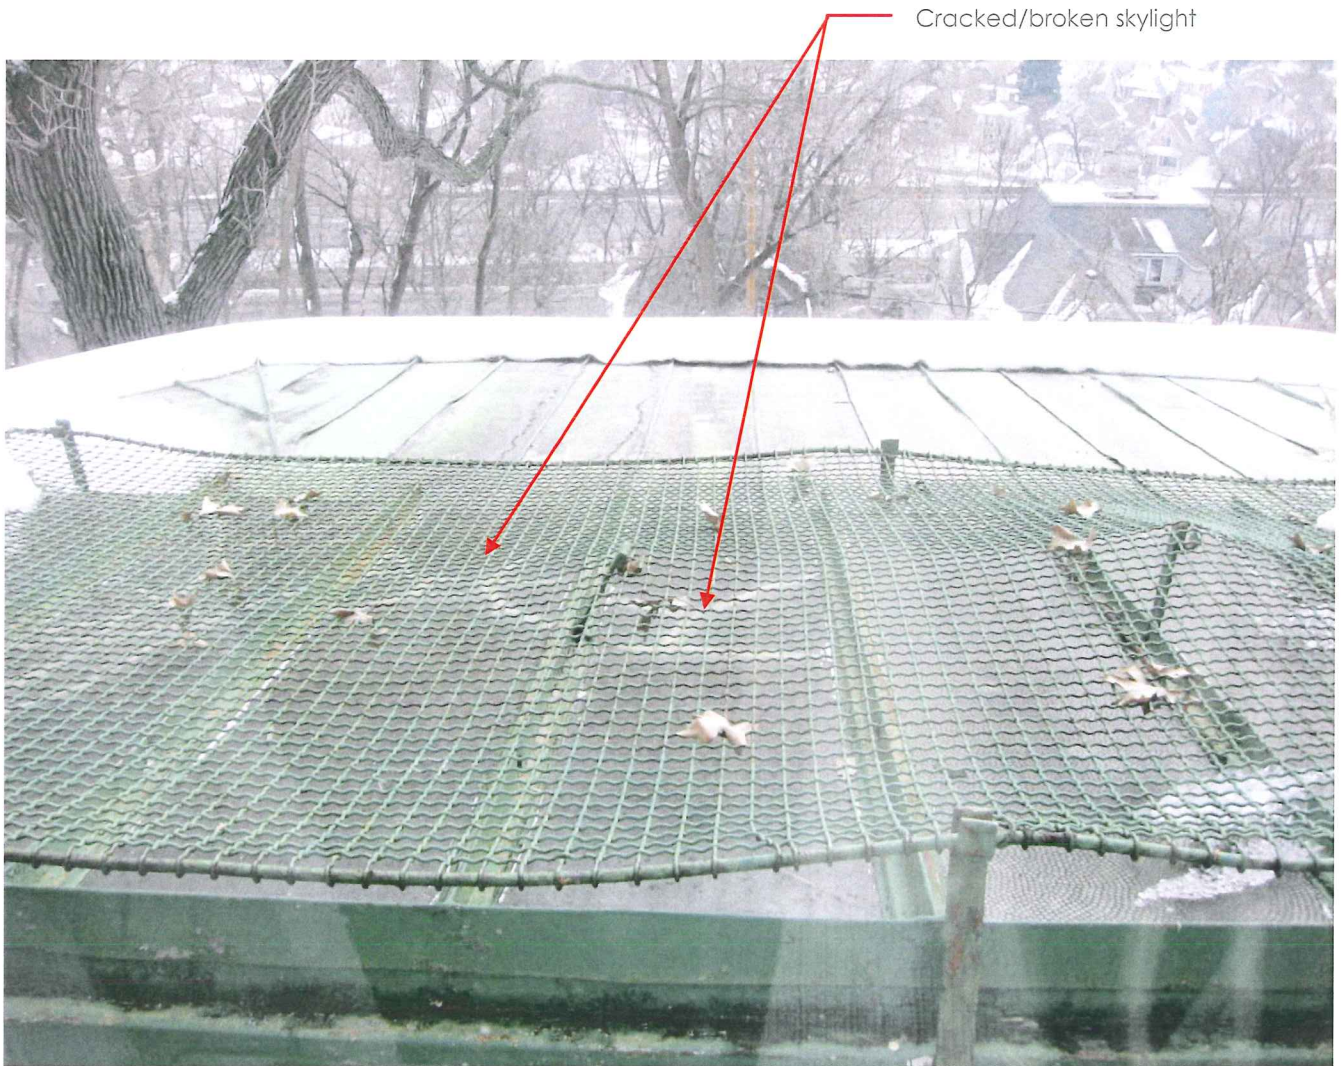
Solarium Skylight Covers

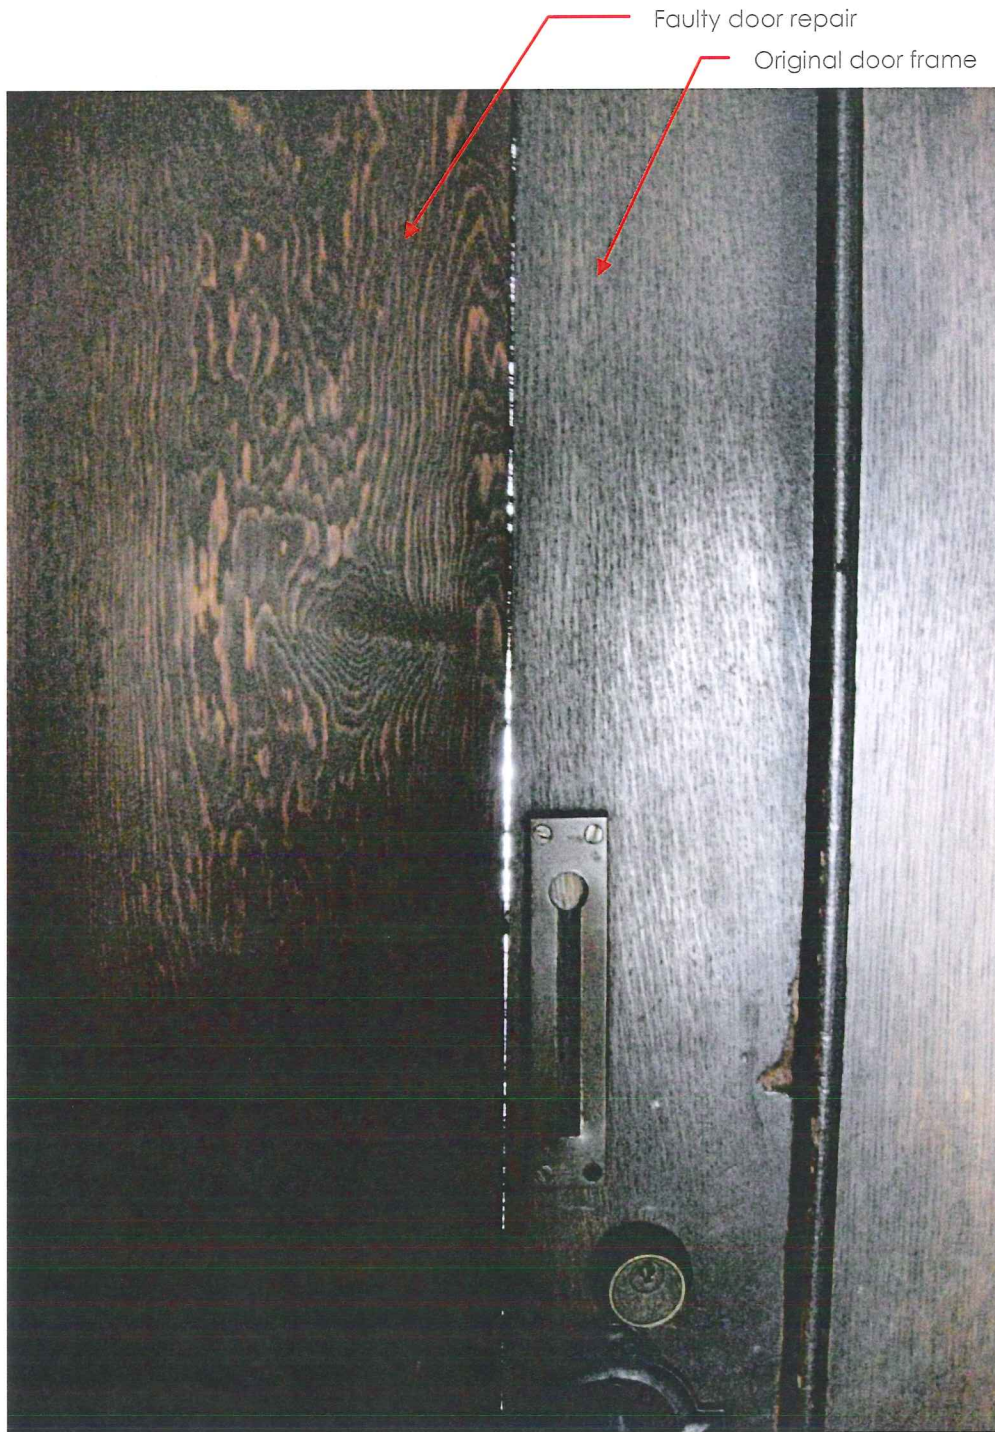
Front Door

- Replacing the front door to match the original design of wood frame and glass panel with a decorative metal grill. The original glass and metal have been removed, however we have the matching metal rail adjacent to the door. We will match the original design, (see orig. front elevation sheet).

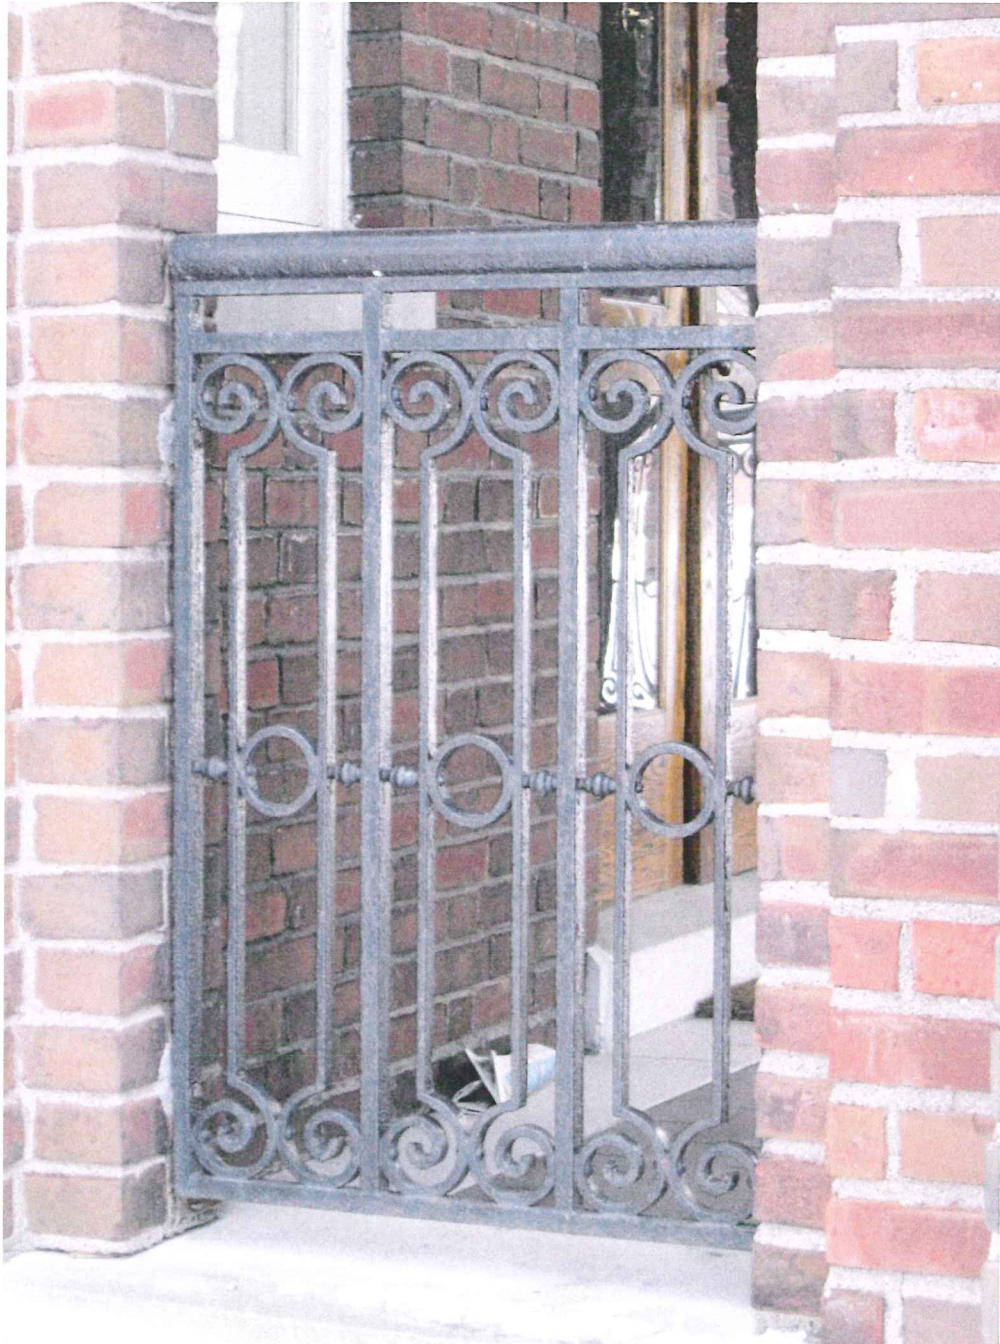
Matching Ironwork at Front Door

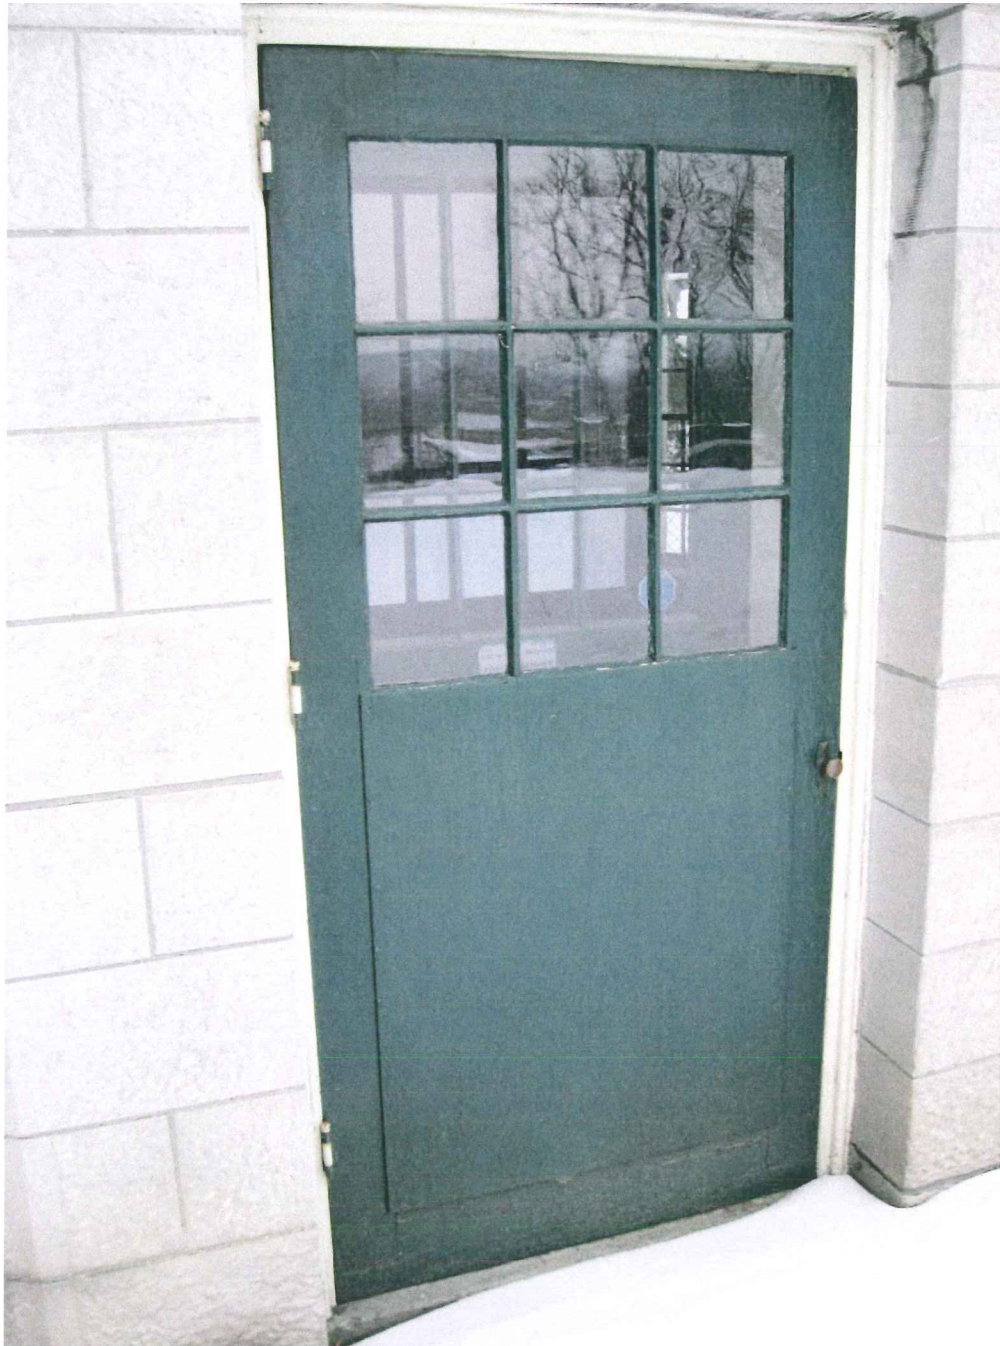
Lower Level Exterior Door

- Replacing the Lower Level exterior door in the octangular bay with a new wood frame/ glass panel security door that matches the design in the original documents. The current door is painted green plywood.

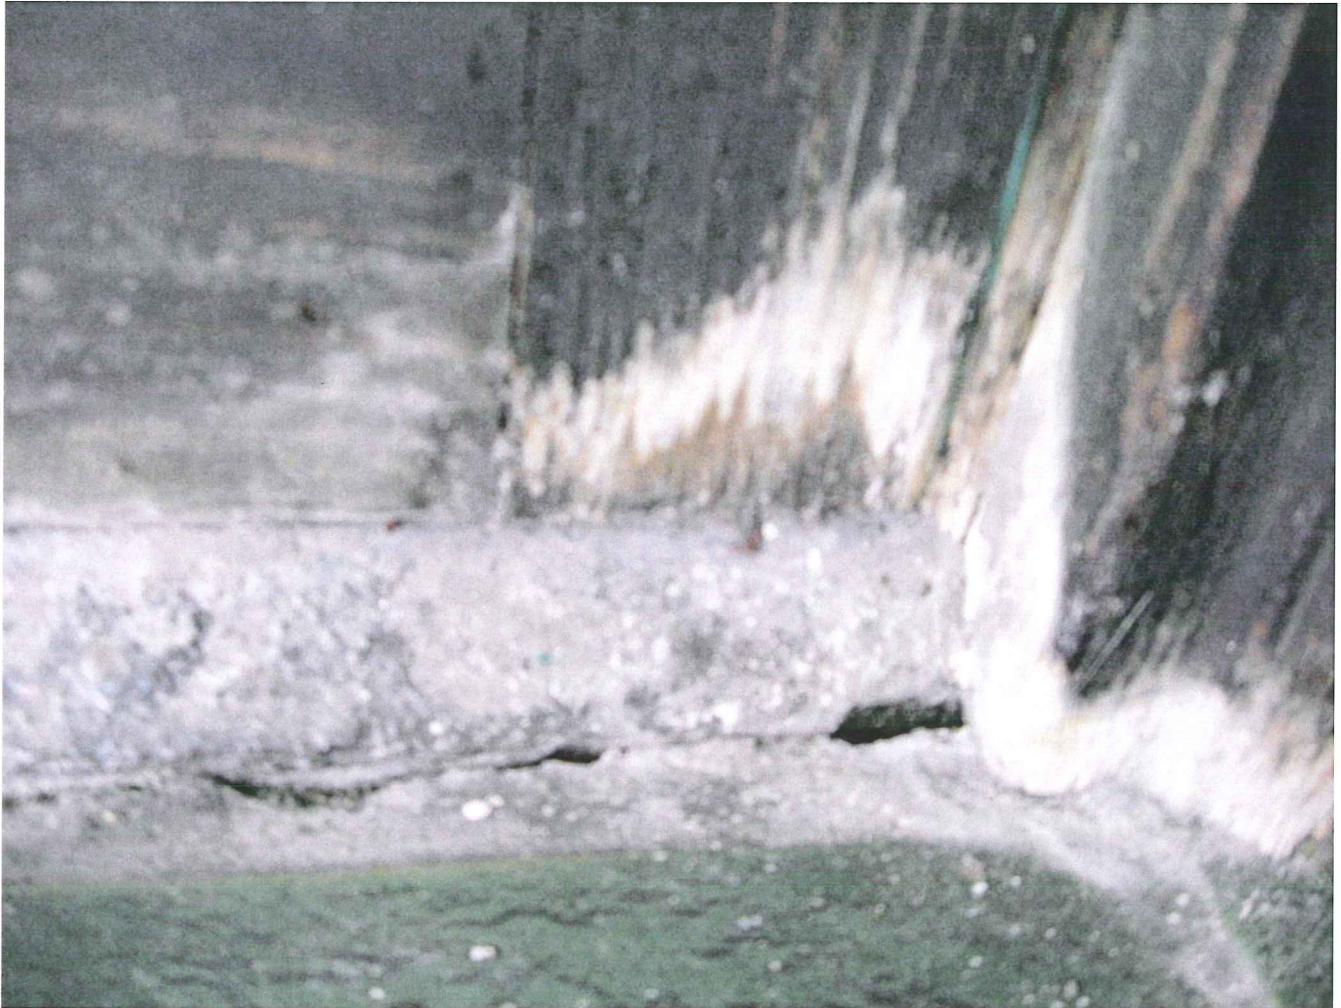
Solarium Exterior Door Sill Rot

- Replacing the exterior door at the Solarium with a new wood frame/ glass panel security door that matches the design in the original documents. The current door has a rotting sill and frame and malfunctioning hardware.

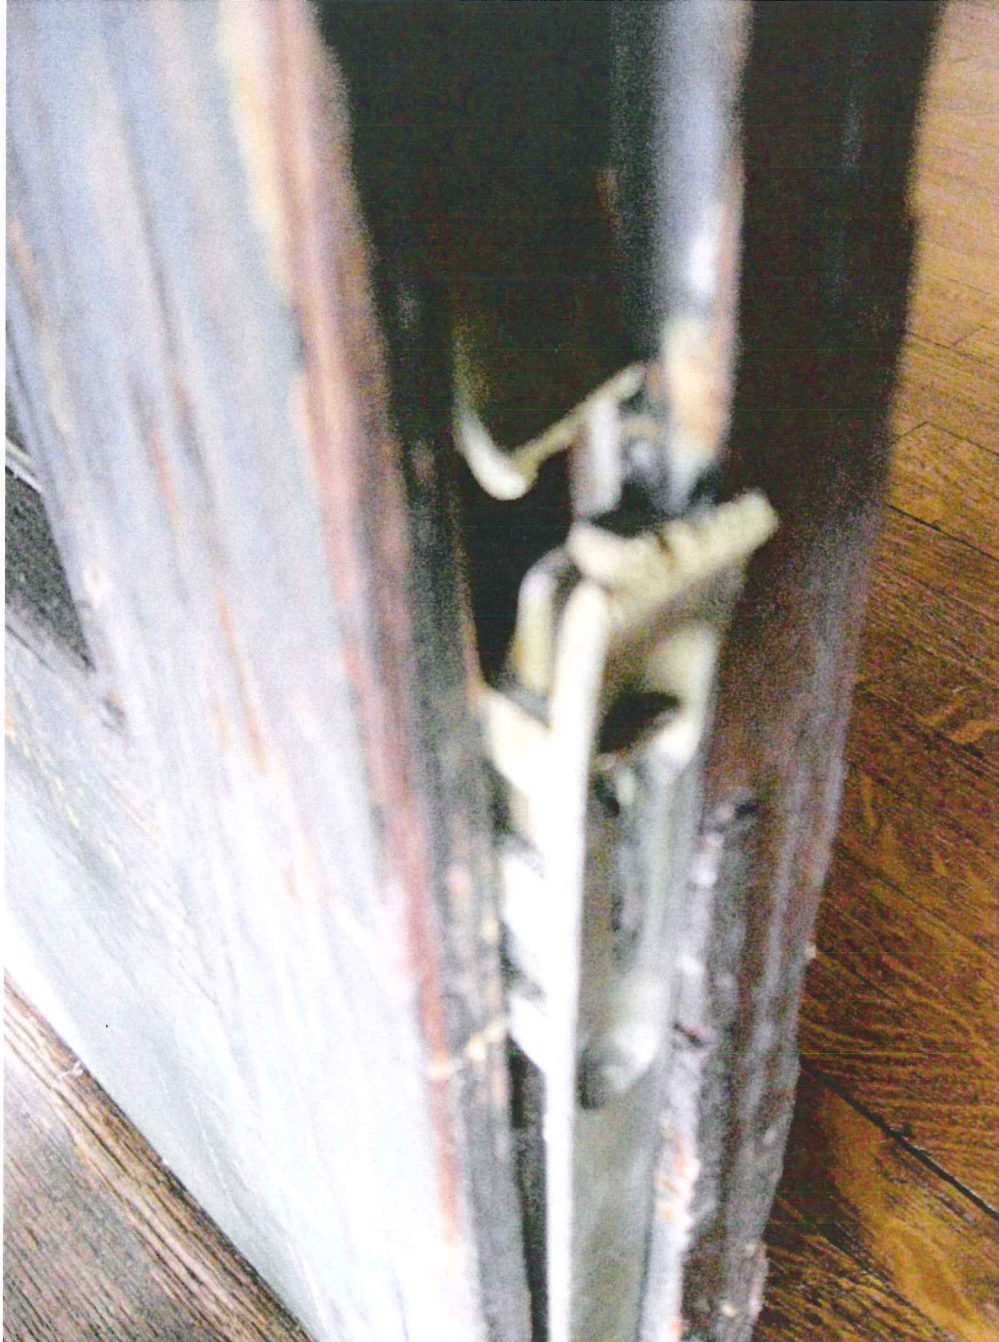
Solarium Exterior Door Rot

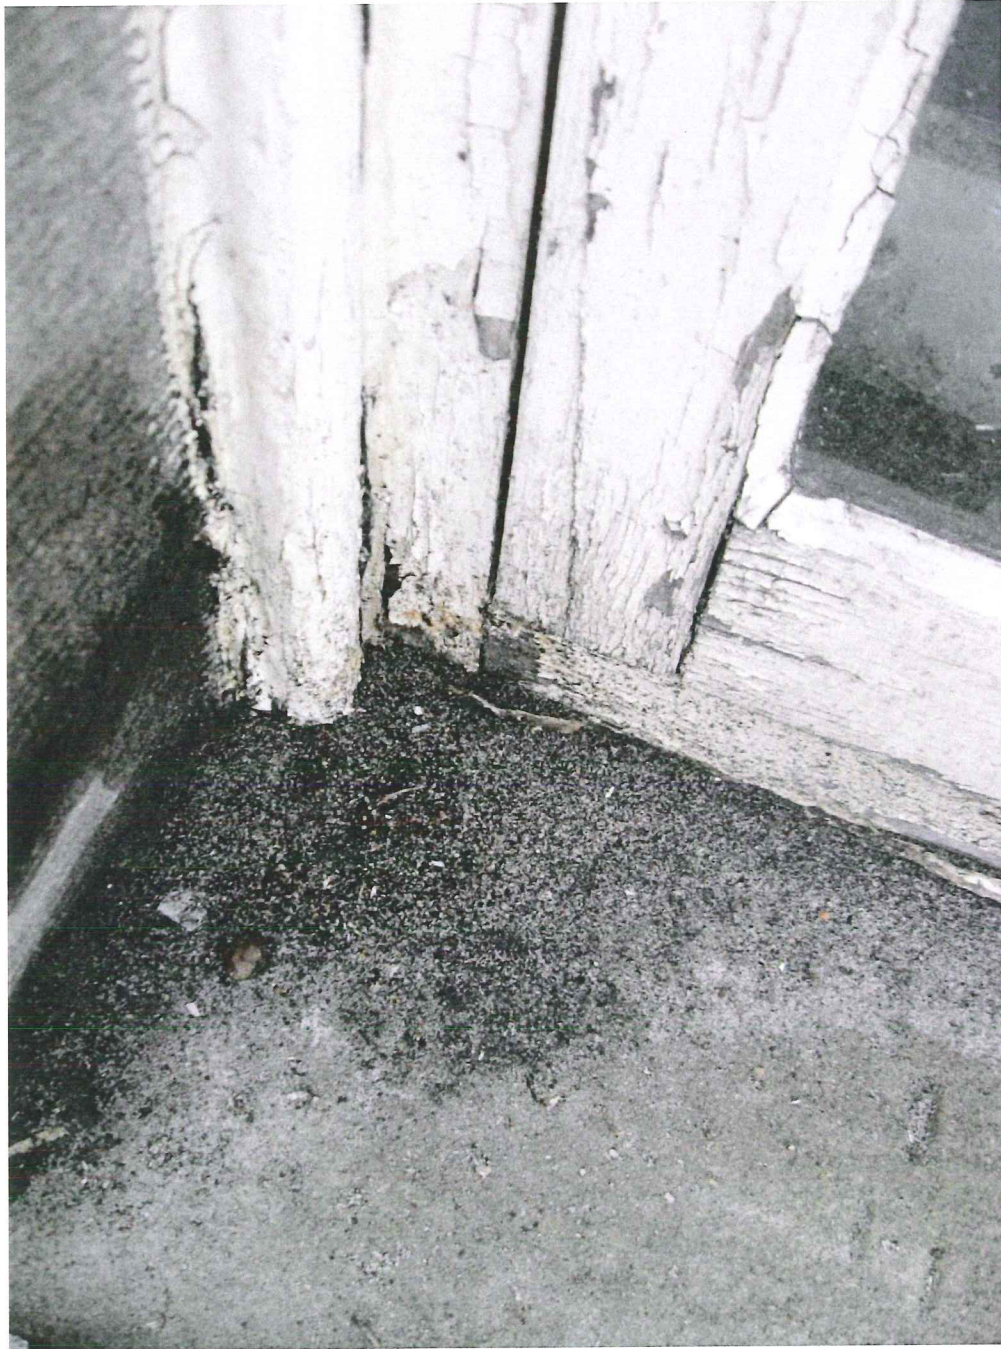
Nearly all of the windows on the Lower Level and Third Floor need replacement due to disrepair, thermal inefficiency and lack of security. The sills on the lower level windows have deteriorated due to rot and pest infiltration. The Third Floor windows appear to not be original. Worker's markings in the metal sash slips are not consistent with the other windows in the house. In addition, water infiltration via the North facing windows has caused severe damage to the wood floors in one of the bedrooms, so much so that it will require them to be totally replaced.

Lower Level Window Sill Rot

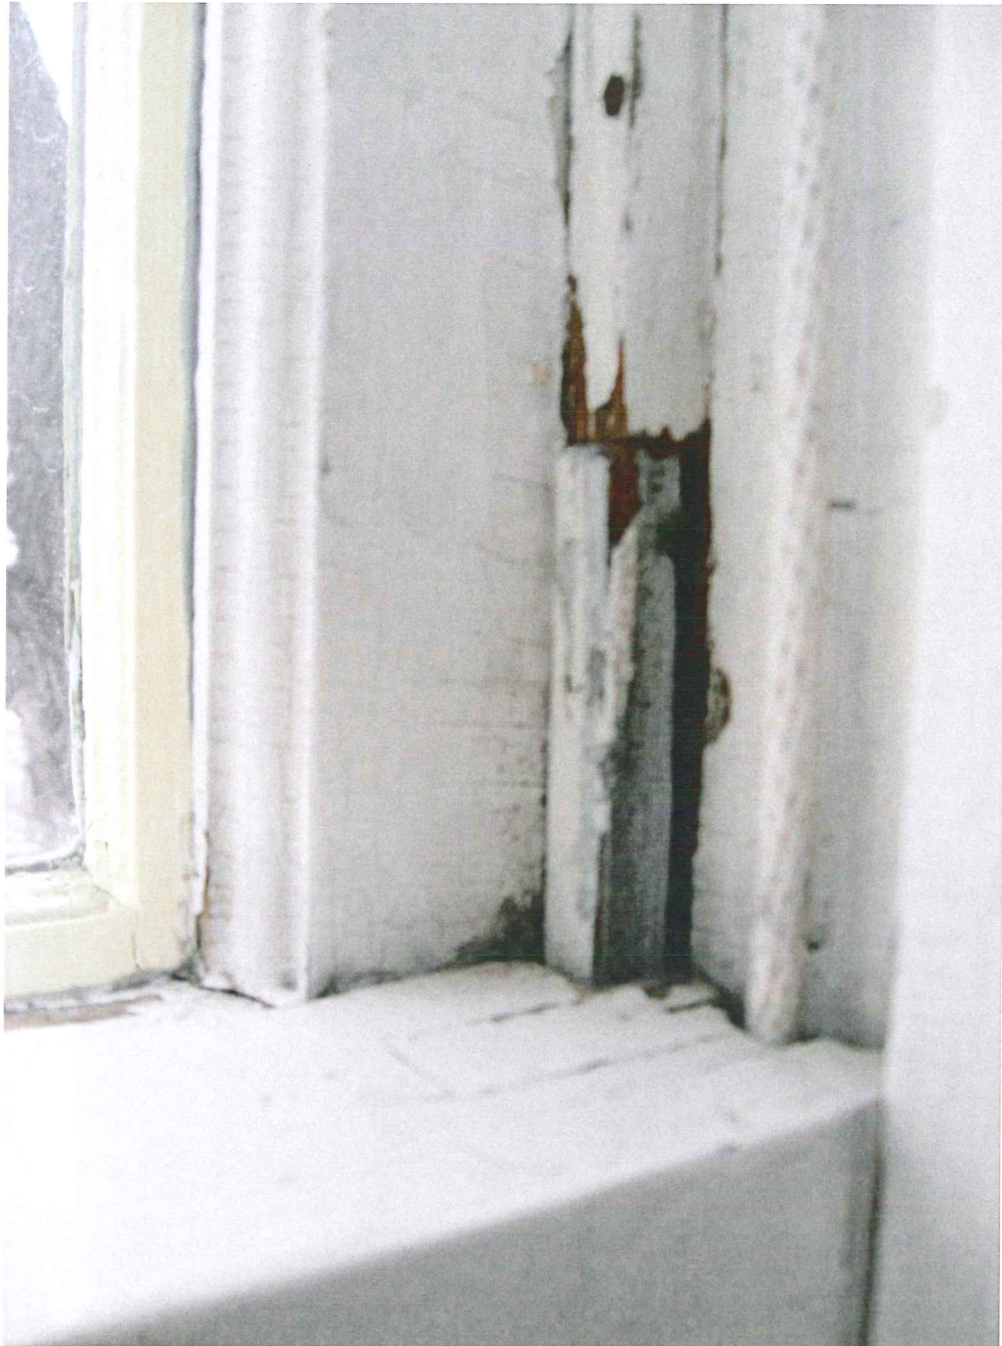
Second Floor Window Rot and Repair

- Replacing the Second Floor windows with custom sized (to match) windows manufactured by Marvin Windows of Warroad, MN. Each unit will be wood framed, Authentic Divided Lites (ADL) with safety glass for security purposes.

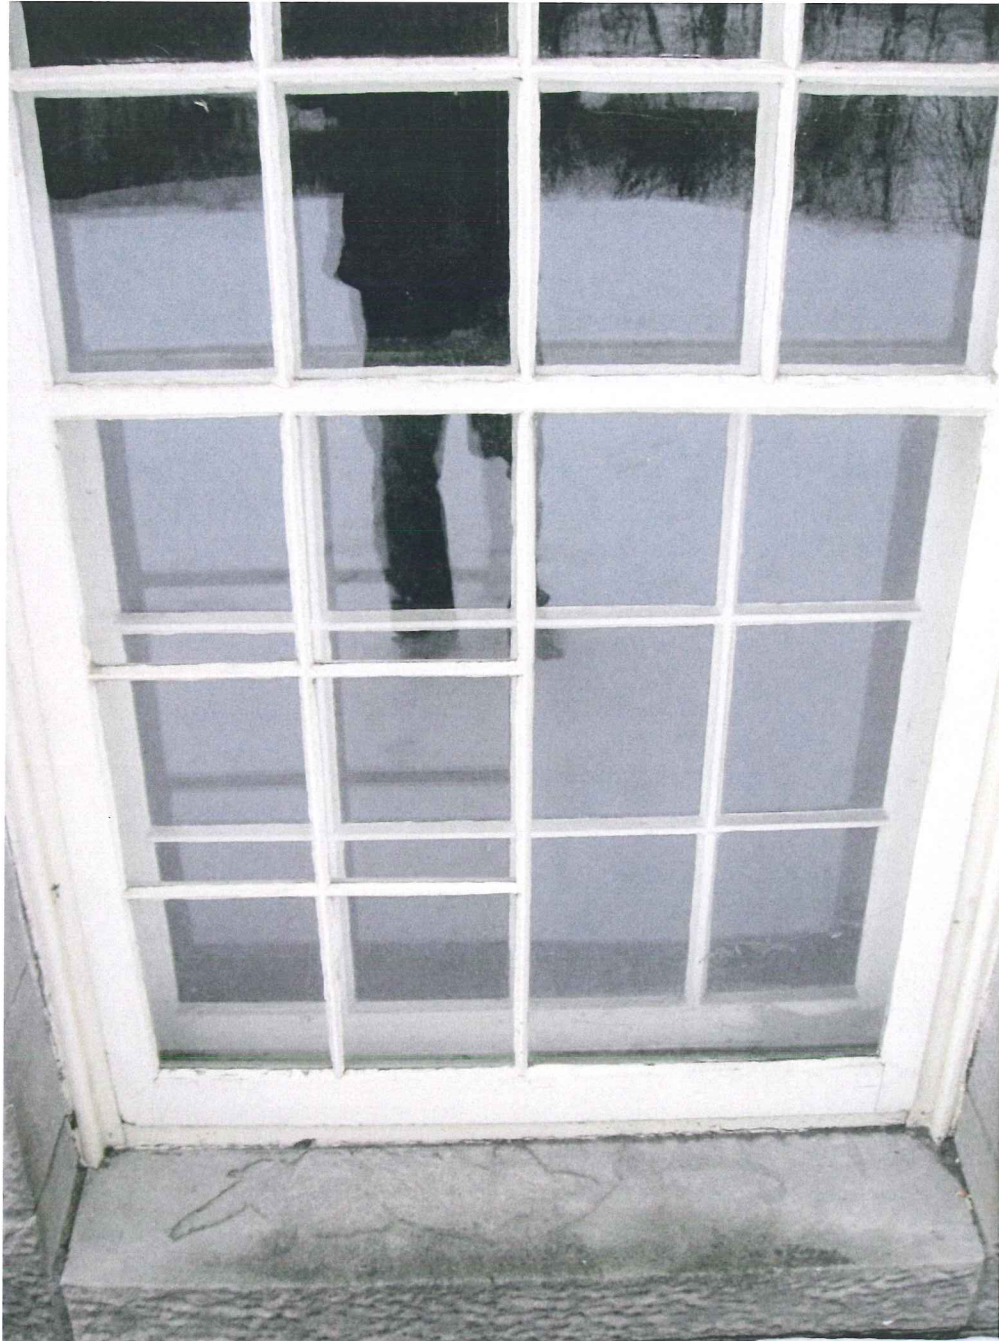
Previous Lower Level Window Repair

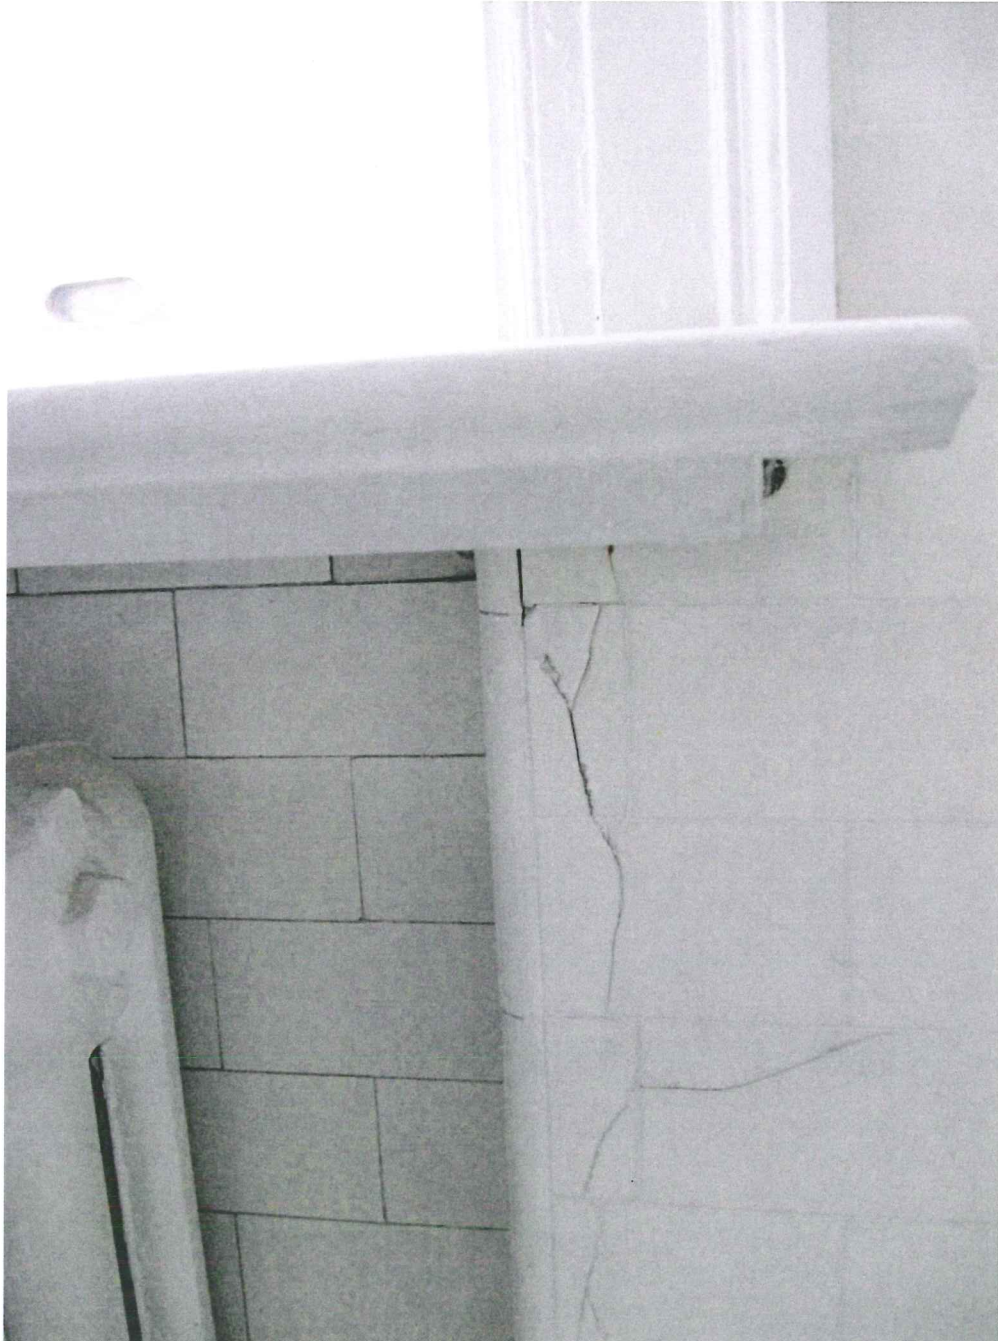
Second Floor Bathroom Window Water  
Damage
